NONDESTRUCTIVE EVALUATION OF DAMAGE
IN METAL MATRIX COMPOSITES

David A. Ulman, Edmund G. Henneke, John C. Duke,
Kenneth L. Reifsnider and Wayne W. Stinchcomb

Final Report
June 1, 1980

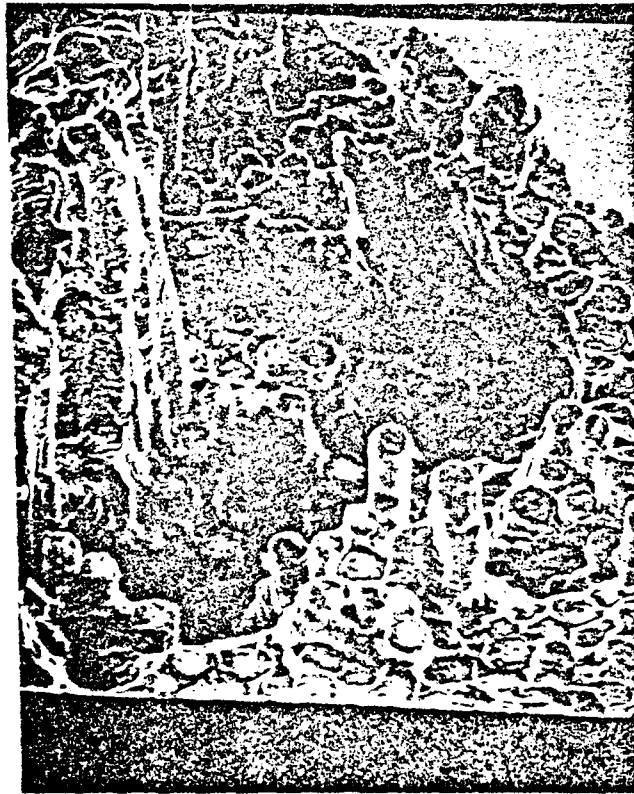
Figure 62: Surface Roughness and Fiber Pullout on specimen 15/5 near tensile edge (300X)

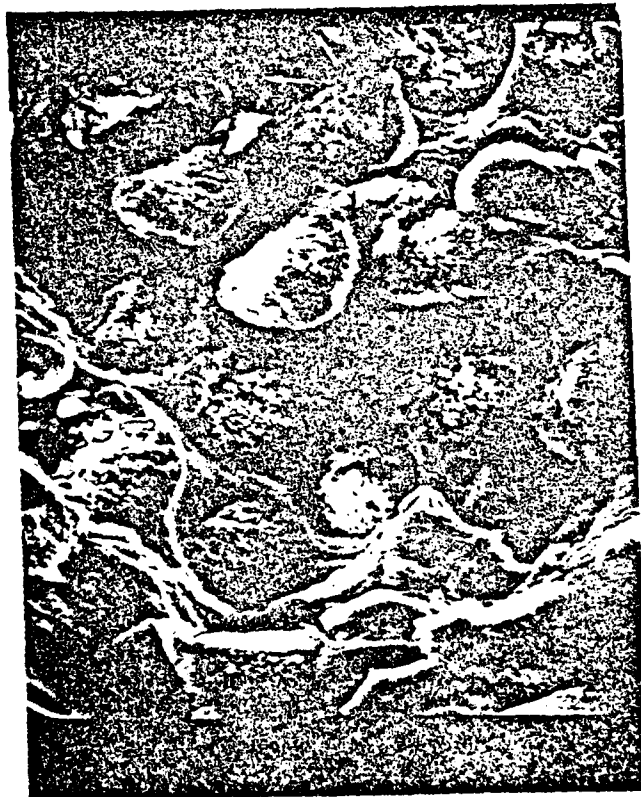
Figure 65: Fatigue crack, specimen 16/5, found near tensile edge
(1000X)

Figures 64, 65 and 68 show fatigue cracks in unnotched specimens

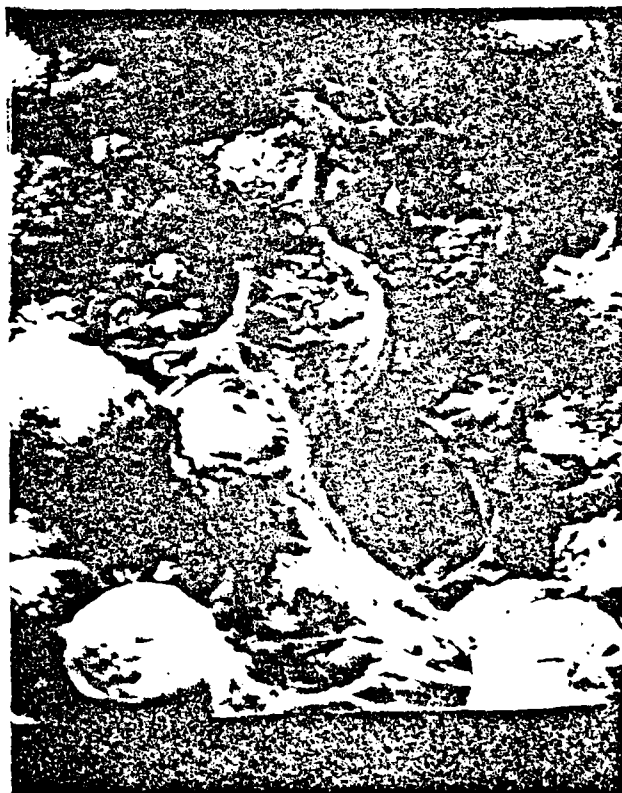
Figure 67: Transverse fatigue crack found on specimen 21/5 (1000X)

while Figures 66 and 67 shown transverse fatigue cracks in the notched specimens. Notice, that in these regions the matrix material is smashed to various particular matter size. In the notched specimen 21/5 (Figures 66 and 67) a total of 90K cycles were performed after the longitudinal crack was detected. Since these surfaces appear to have finer particular matter than those in Figures 64 and 65, the implication is that the transverse cracks in the unnotched specimens grow to catastrophic lengths very rapidly, i.e., over a few number of load cycles.
